AFWL-TR-77-274

## FRACTURE ANALYSIS OF REENTRY VEHICLE STRUCTURAL MATERIALS

September 1978

Final Report

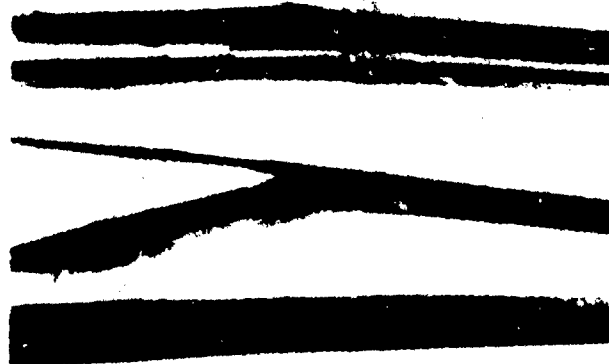
Samples which had been degraded by mechanical impact prior to test are shown in figures 20, 21, 22, and 23 after they had been tested. There appeared to be virtually no difference between the degraded specimens and the specimens made of virgin material. As in the virgin material, the specimens in the "circumferential" orientation broke with finer delaminations when tested dynamically than when tested statically - see figures 20b and 21b. There did not appear to be significant difference between the two test conditions in the "axial" specimens.

Figure 20. G/E Specimens After Test; Degraded Material, Static Test, "Circumferential" Orientation. (a) Edge View 2X. (b) Edge View 10X.

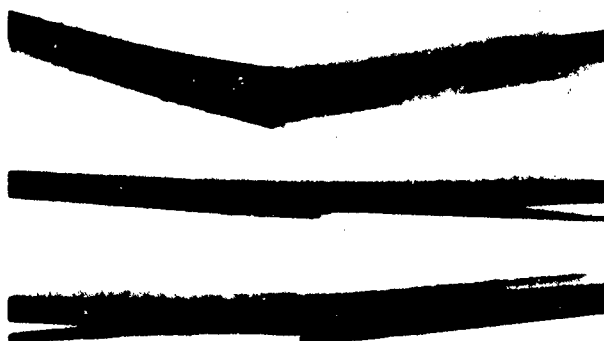
Figure 21. G/E Specimens After Test; Degraded Material, Dynamic Test, "Circumferential" Orientation. (a) Edge View 2X. (b) Edge View 10X.

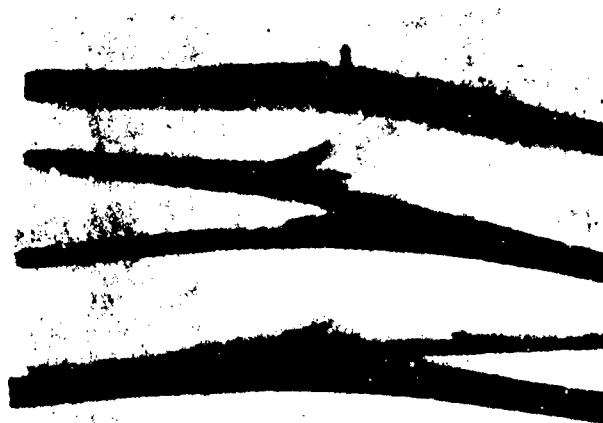
Figure 22. G/E Specimens After Test; Degraded Material,  
Static Test, "Axial" Orientation. 2X.

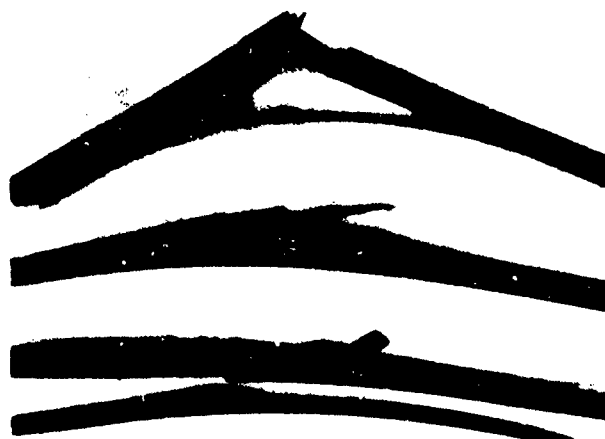
Figure 23. G/E Specimens After Test; Degraded Material,  
Dynamic Test, "Axial" Orientation. 2X.
